# New Hampshire Volunteer Lake Assessment Program

## 2003 Biennial Report for White Oak Pond Holderness

NHDES  
Water Division  
Watershed Management Bureau  
29 Hazen Drive  
Concord, NH 03301

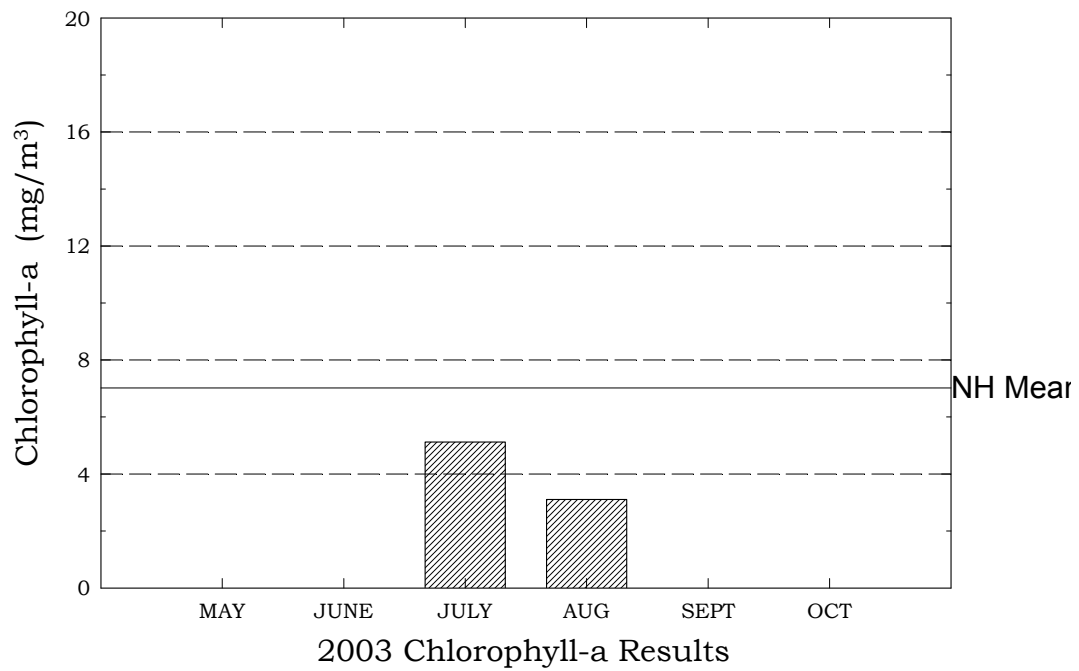
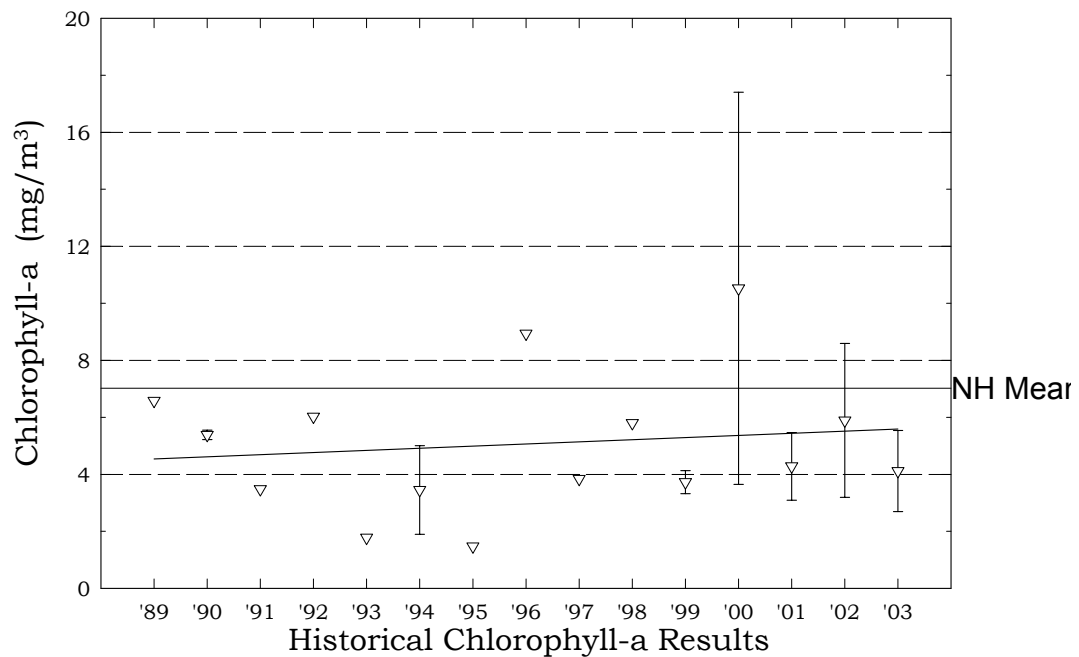
**Figure 1.** Monthly and Historical Chlorophyll-a Results

- **Figure 1 and Table 1:** The graphs in Figure 1 (Appendix A) show the historical and current year chlorophyll-a concentration in the water column. Table 1 (Appendix B) lists the maximum, minimum, and mean concentration for each sampling season that the lake/pond has been monitored through the program.

The current year data (the top graph) show that the chlorophyll-a concentration **decreased** from July to August. The chlorophyll-a concentration on both sampling events was **less than** the state mean. Overall, the statistical analysis of the historical data (the bottom graph) shows that the mean annual chlorophyll-a concentration has **not significantly changed** since monitoring began in **1989**. Specifically, the mean annual chlorophyll concentration has **varied**, but has not *continually increased* or *decreased* since monitoring began. (Note: Please refer to Appendix E for the detailed statistical analysis explanation and data print out.)

While algae are naturally present in all lakes/ponds, an excessive or increasing amount of any type is not welcomed. In freshwater lakes/ponds, phosphorus is the nutrient that algae depend upon for growth. Algal concentrations may increase with an increase in nonpoint sources of phosphorus loading from the watershed, or in-lake sources of phosphorus loading (such as phosphorus releases from the sediments). Therefore, it is extremely important for volunteer monitors to continually educate residents about how activities within the watershed can affect phosphorus loading and lake/pond quality.

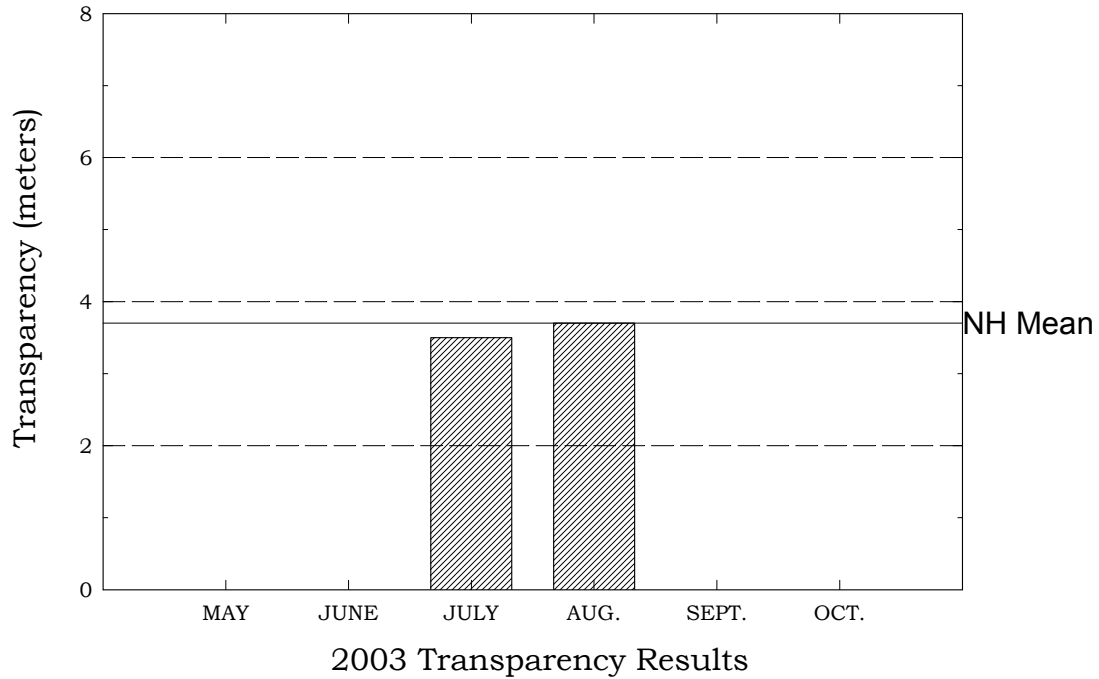
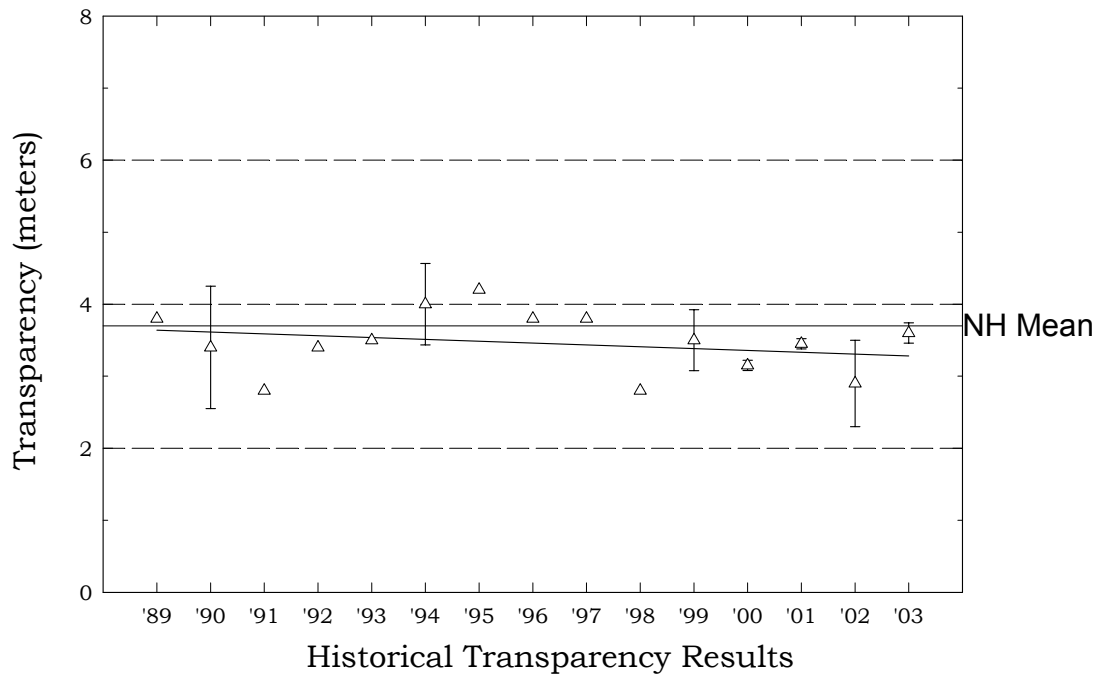
**Figure 2.** Monthly and Historical Transparency Results

- **Figure 2 and Table 3:** The graphs in Figure 2 (Appendix A) show historical and current year data for lake/pond transparency. Table 3 (Appendix B) lists the maximum, minimum and mean transparency data for each sampling season that the lake/pond has been monitored through the program.

The current year data (the top graph) show that the in-lake transparency **increased very slightly** from July to August. The transparency in July was **slightly less than** the state mean, while the transparency in August was **approximately equal to** the state mean.

Overall, the statistical analysis of the historical data (the bottom graph) show that the mean annual in-lake transparency has **not significantly changed** (either *increased* or *decreased*) since monitoring began in **1989**. Specifically, the transparency has

remained **relatively stable, ranging between approximately 3 and 4 meters.**

Typically, high intensity rainfall causes erosion of sediments into lakes/ponds and streams, thus decreasing clarity. Efforts should continually be made to stabilize stream banks, lake/pond shorelines, disturbed soils within the watershed, and especially dirt roads located immediately adjacent to the edge of tributaries and the lake/pond. Guides to Best Management Practices designed to reduce, and possibly even eliminate, nonpoint source pollutants, such as sediment loading, are available from DES upon request.

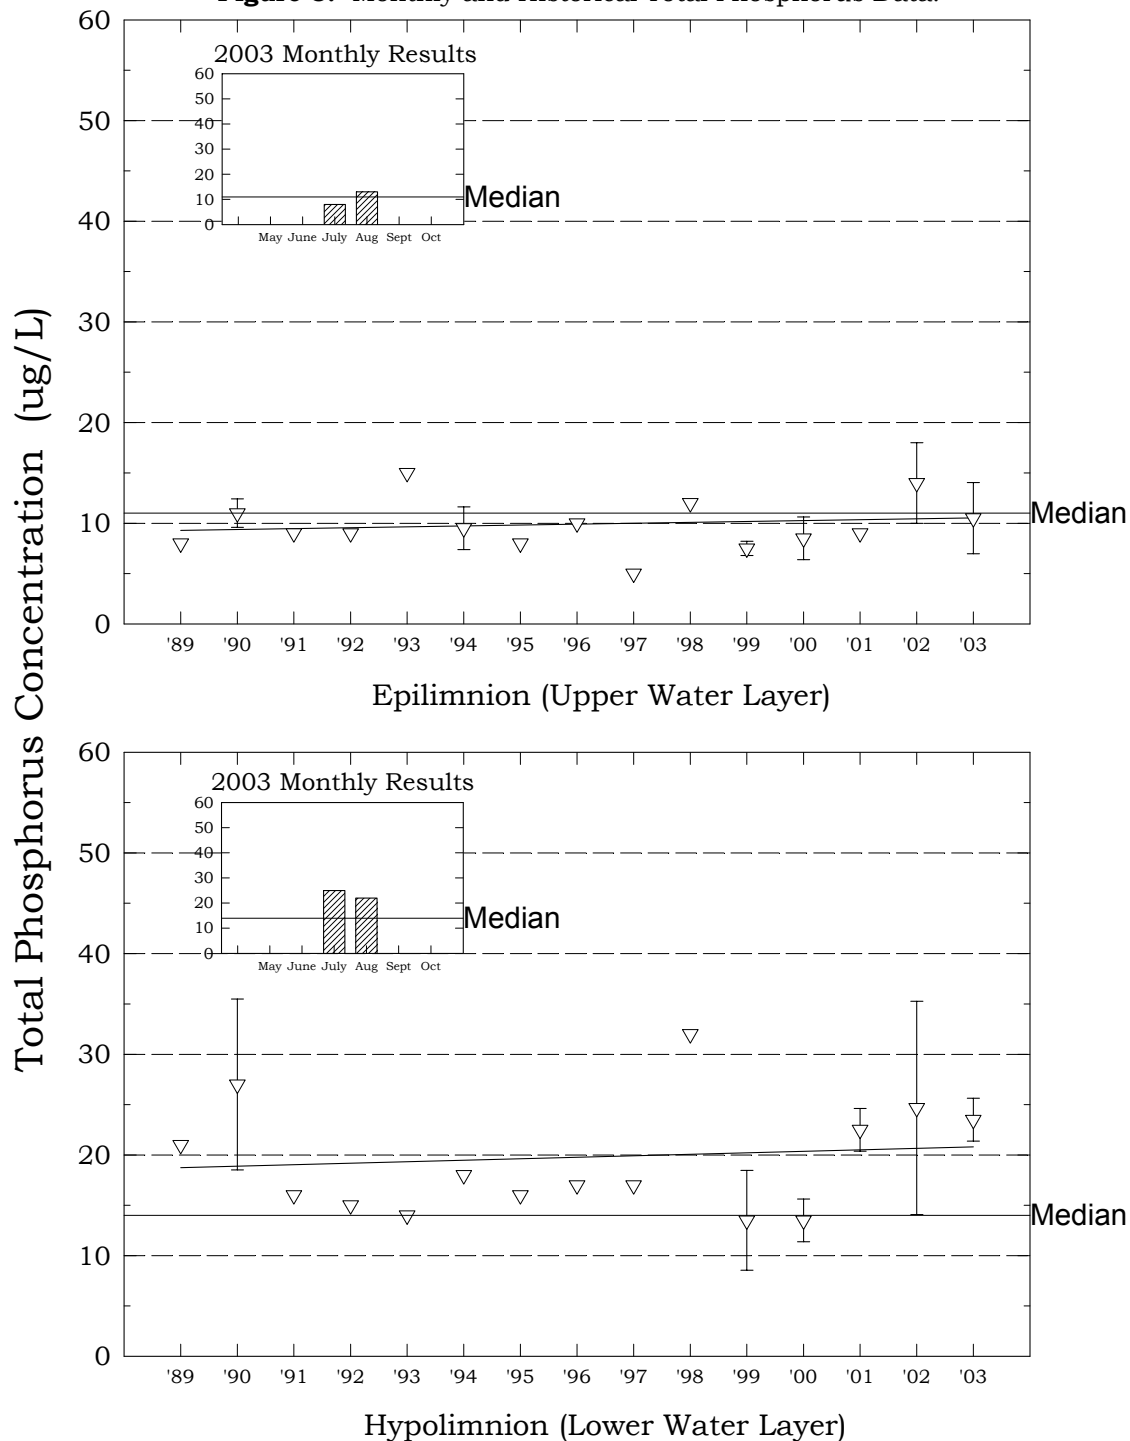
**Figure 3.** Monthly and Historical Total Phosphorus Data.

- **Figure 3 and Table 8:** The graphs in Figure 3 (Appendix A) show the amounts of phosphorus in the epilimnion (the upper layer) and the hypolimnion (the lower layer); the inset graphs show current year data. Table 8 (Appendix B) lists the annual maximum, minimum, and median concentration for each deep spot layer and each tributary since the lake/pond has joined the program.

The current year data for the epilimnion (the top inset graph) show that the phosphorus concentration **increased slightly** from July to August. The phosphorus concentration in July was **slightly less than** the state median, while the concentration in August was **slightly greater** than the state median.

The historical data show that the 2003 mean epilimnetic phosphorus concentration is **approximately equal to** the state median.

The current year data for the hypolimnion (the bottom inset graph) show that the phosphorus concentration **decreased slightly** from July to August. The phosphorus concentration on both sampling event was **greater than** the state median.

Overall, the statistical analysis of the historical data show that the phosphorus concentration in the epilimnion (upper layer) and the hypolimnion (lower layer) has **not significantly changed** since

monitoring began in **1989**. Specifically, the mean annual phosphorus concentration in the epilimnion has remained **relatively stable, ranging between approximately 8 and 12 ug/L**. The phosphorus concentration in the hypolimnion has **fluctuated**, but has not *continually increased or continually decreased* since monitoring began.

It is also important to point out that the phosphorus concentration in the hypolimnion has generally been **greater than** in the epilimnion. This suggests that the process of **internal phosphorus loading** is occurring in the hypolimnion. (Please refer to the discussion of Table 9 and 10 for a more detailed explanation of internal phosphorus loading).

One of the most important approaches to reducing phosphorus loading to a waterbody is to continually educate watershed residents about its sources and how excessive amounts can adversely impact the ecology and value of lakes and ponds. Phosphorus sources within a lake or pond's watershed typically include septic systems, animal waste, lawn fertilizer, road and construction erosion, and natural wetlands.
